Manhole Inspection Summary

Manhole # S23I__019MH

Location Address: **31 S Morris St**

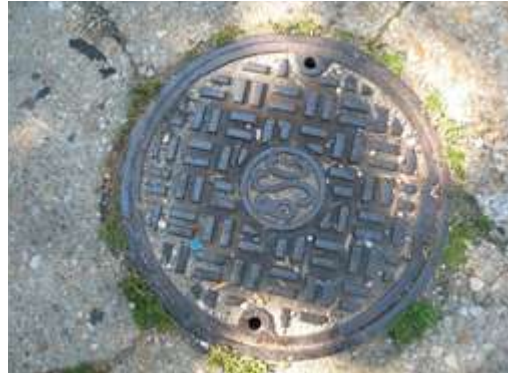
Cover View

Type: **Sanitary** Condition: **Sound** Cover Material: **Cast Iron**

Frame Offset: **0** (in.) Condition: ☐ Sound ☐ Cracked ☒ **Leaks**

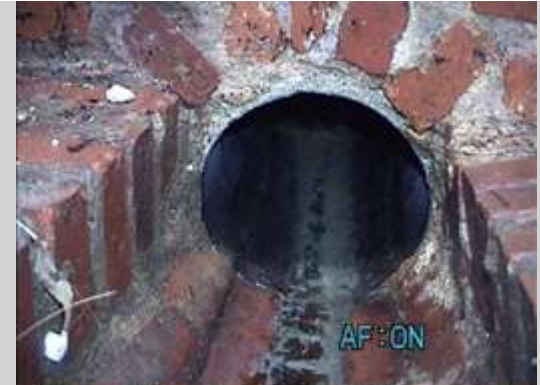
12 O'Clock Outflow

8 in. Circular Gravity Sewer
Pipe Out @ 12 O'Clock

Invert Depth: **8.81** (ft.) Flow Characteristics: **None**

Deposits: ☒ None ☐ Mud ☐ Sludge ☐ Debris ☐ Grease

Infiltration: **None** Pipe Seal Cond: **Sound**

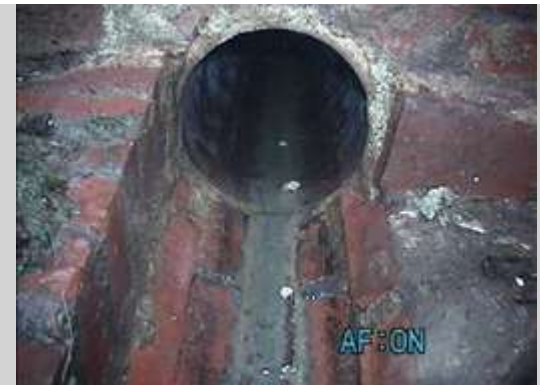
6 O'Clock Inflow

8 in. Circular Gravity Sewer
Pipe In @ 6 O'Clock

Invert Depth: **8.19** (ft.) Flow Characteristics: **None**

Deposits: ☒ None ☐ Mud ☐ Sludge ☐ Debris ☐ Grease

Infiltration: **None** Pipe Seal Cond: **Sound**

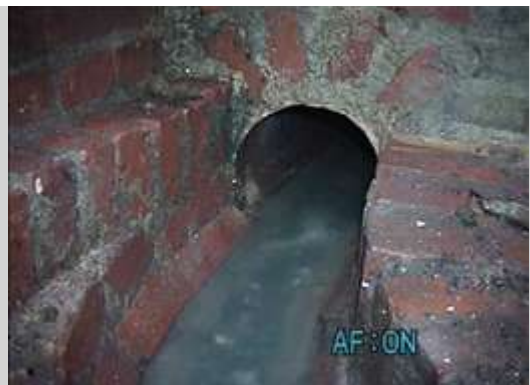
8 O'Clock Inflow

8 in. Circular Gravity Sewer
Pipe In @ 8 O'Clock

Infiltration: **None** Pipe Seal Cond: **Sound**
